## DIGHTON BUILDING AUDITS

*KMA audited the following buildings:*

## ANIMAL SHELTER

AUDITED ON: APRIL 10, 2020 & JUNE 9, 2020

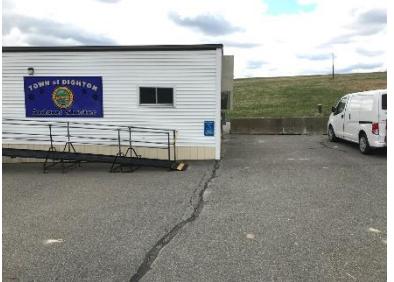
#	Barrier Statement	Photo	Proposed Mitigation	Cost
1.	<p><b>Accessible Parking</b></p> <p>The designated accessible parking space lacks striping.</p> <p>The designated accessible parking space has slopes &gt;2%.</p> <p>The sign is mounted &lt;60" AFF to the bottom of the sign.</p>

<p>Regrade and stripe the existing designated accessible parking space and its associated access aisle.</p> <p>Unit Cost: \$1,500 per space or aisle</p> <p>Est. Quantity: 2 (1 space + 1 aisle)</p> <p>Install a new van accessible sign at min. 60" AFF measured to the bottom of the sign.</p> <p>Unit Cost: \$100 ea.</p> <p>Quantity: 1</p>	\$3,100

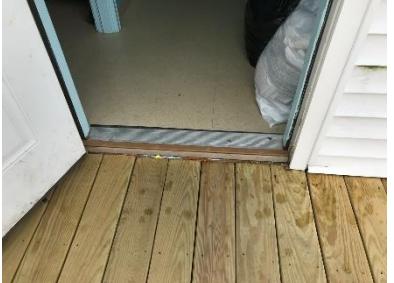
3.	<p><b>Entry Door</b></p> <p>The threshold is &gt;0.5" AFF, @ 1.75".</p>

<p>Replace the threshold.</p> <p>Unit Cost: \$250 ea.</p> <p>Quantity: 1</p>	\$250

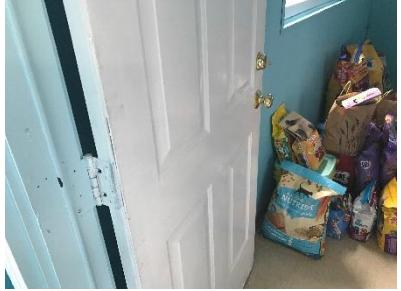
4.	<p><b>Door Hardware – Typical</b></p> <p>The door hardware requires tight grasping, pinching, or twisting of the wrist to operate.</p>

<p>Replace the door hardware with lever type.</p> <p>Unit Cost: \$300 ea.</p> <p>Est. Quantity: 3</p>	\$900

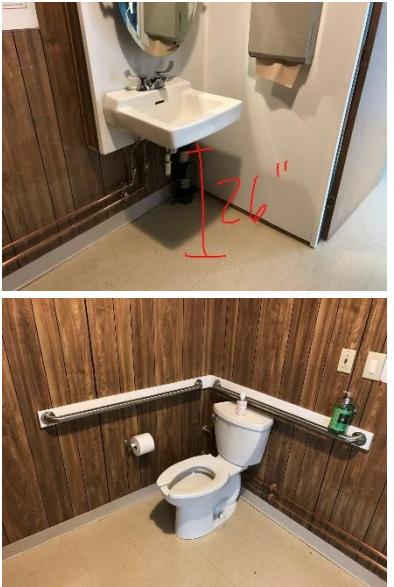
5.	<p><b>Toilet Room</b></p> <p>The knee clearance at the sink is &lt;27" AFF, @ 26".</p> <p>The toilet centerline is &gt;18" from the side wall, @ 18.25".</p> <p>The side grab bar extends &lt;54" from the rear wall, @ 47.5".</p> <p>The flush valve is not located on the open side of the toilet.</p> <p>The sink pipes are not insulated.</p> <p>The toilet paper dispenser is not located 7 – 9" from the front of the toilet.</p>

<p>Raise the sink to provide the required knee clearance.</p> <p>Unit Cost: \$750 ea.</p> <p>Quantity: 1</p> <p>Reposition the toilet.</p> <p>Unit Cost: \$1,500 ea.</p> <p>Quantity: 1</p> <p>Install a 42" min. side grab bar, located 12" from the interior corner of the wall.</p> <p>Unit Cost: \$50 ea.</p> <p>Quantity: 1</p> <p>Reposition the flush valve or install an automatic flush control.</p> <p>Unit Cost: \$1,000 ea.</p> <p>Quantity: 1</p> <p>Insulate the pipes.</p> <p>Unit Cost: \$50</p> <p>Quantity: 1</p> <p>Relocate the toilet paper dispensers.</p> <p>Unit Cost: \$50 ea.</p> <p>Quantity: 1</p>	\$3,400

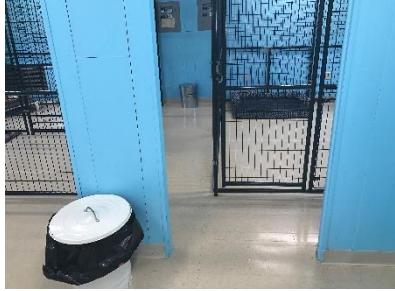
6.	<p><b>Kennels</b></p> <p>The kennels are not located on a minimum 36" wide accessible route, @ 24"-27" between the wall and the cages.</p> <p><i>KMA was informed on site that only employees are required to access the kennel area.</i></p>

<p>Relocate the cages to provide a minimum 36" wide accessible route.</p> <p>Unit Cost: \$500</p> <p>Quantity: 1</p>	\$500
<b>TOTAL FOR ANIMAL SHELTER:</b>		<b>\$23,150</b>

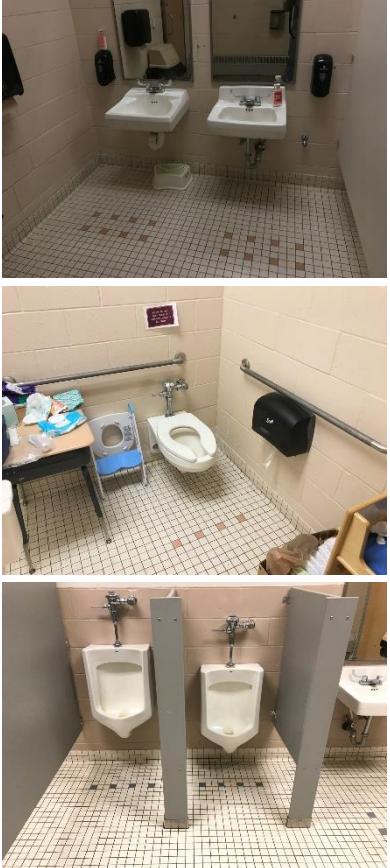
4.	<p><b>Multi-User Toilet Rooms (2)</b></p> <p>The dispensers protrude &gt;4" into the circulation space, @ 6.5".</p> <p>The rear grab bar starts &gt;12" from the side wall, @ 13".</p> <p>The urinal is in an alcove that is &lt;30" wide, @ 26.5".</p> <p>In one of the toilet rooms furniture obstructs the accessible toilet stall.</p>

<p>Relocate the dispensers. Unit Cost: \$50 ea. Quantity: 4</p> <p>Install a 42" min. side grab bar, located 12" from the interior corner of the wall. Unit Cost: \$50 ea. Quantity: 2</p> <p>Relocate the partition. Unit Cost: \$50 Quantity: 1</p> <p>Remove the furniture. Unit Cost: \$50 Quantity: 1</p>	\$400
<b>TOTAL FOR DIGHTON ELEMENTARY SCHOOL:</b>				<b>\$9,600</b>

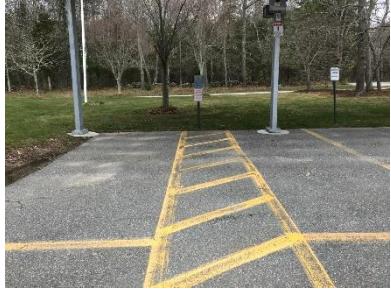
#	<i>Barrier Statement</i>	<i>Photo</i>	<i>Proposed Mitigation</i>	<i>Cost</i>
1.	<b>Accessible Parking</b> One of the designated accessible parking spaces lacks a sign. One of the designated accessible parking signs is not located at the head of the space and is mounted <60" AFF, @ 52.5" to the bottom of the sign. The access aisle is <96" wide.

Install new signs at min. 60" AFF (including a van accessible sign), measured to the bottom of the sign. Unit Cost: \$100 ea. Quantity: 2  Restripe the existing designated accessible parking spaces and the access aisle. Unit Cost: \$300 per space or aisle Est. Quantity: 3 (2 spaces + 1 aisle)	\$1,100

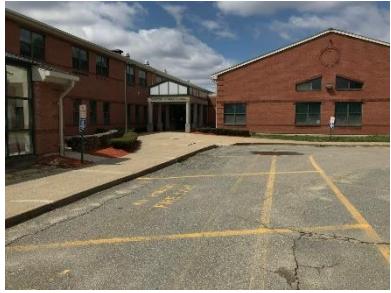
2.	<b>Passenger Drop-Off Area</b> The designated drop-off area lacks an accessible passenger loading zone.

Install an accessible passenger loading zone. Unit Cost: \$1,000 ea. Quantity: 1	\$1,000

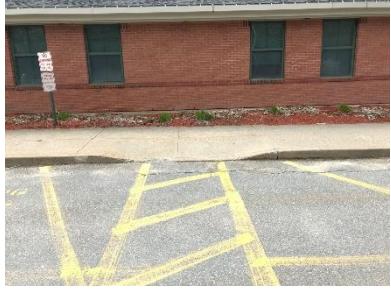
3.	<b>Accessible Route</b> The curb ramps have running slopes >8.3%, @ up to 13.7%.

Rebuild the curb ramps. Unit Cost: \$1,250 ea. Quantity: 2	\$2,500

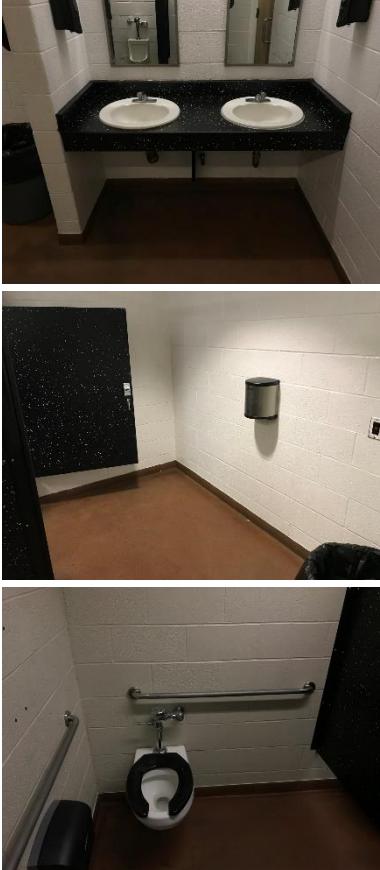
4.	<p><b>Multiuser Toilet Rooms (2)</b></p> <p>In one of the toilet rooms, the knee clearance at the sink is &lt;27" AFF, @ 26".</p> <p>In one of the toilet rooms, the dispenser protrudes &gt;4" into the circulation space, @ 7".</p> <p>In one of the toilet rooms, the rear grab bar extends &lt;12" from the centerline of the toilet, @ 6".</p> <p>In one of the toilet rooms, the flush control is not located on the open side of the toilet.</p>

<p>Raise the sink to provide the required knee clearance. Unit Cost: \$750 ea. Quantity: 1</p> <p>Relocate the dispenser. Unit Cost: \$50 ea. Quantity: 1</p> <p>Relocate the grab bar. Unit Cost: \$50 ea. Quantity: 1</p> <p>Reposition the flush valve or install an automatic flush control. Unit Cost: \$1,500 ea. Quantity: 1</p>	\$2,350

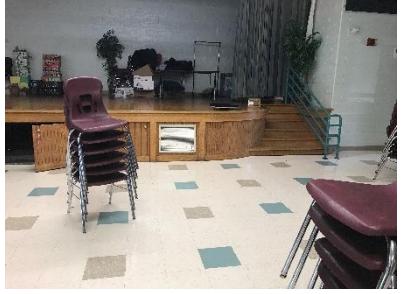
6.	<p><b>Stage - Cafeteria</b></p> <p>The stage is not located on an accessible route, due to the change in level.</p> <p><i>KMA was informed on site that the stage is used for Town events such as school plays.</i></p>

<p>Provide an accessible route to the stage.</p> <p>Additional study required.</p> <p>Unit Cost: \$10,000</p> <p>Quantity: 1</p>	\$10,000
7.	<p><b>Exit Door – Cafeteria</b></p> <p>There is a change in level &gt;1/4" AFF at the exit door, @ 1".</p>

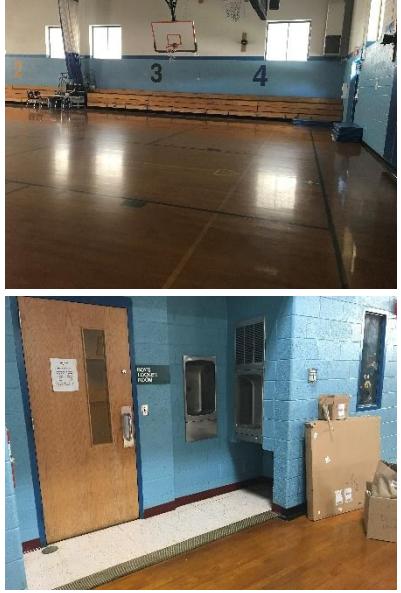
8.	<p><b>Gym</b></p> <p>The threshold is &gt; 0.5" AFF, @ 0.75".</p> <p>Accessible seating is not provided at the pull-out bleachers.</p> <p>The drinking fountains are mounted too high.</p>

<p>Replace the threshold. Unit Cost: \$250 ea. Quantity: 1</p> <p>Provide the required number of accessible seats at the bleachers. Further design study required.</p> <p>Unit Cost: \$5,000</p> <p>Relocate the drinking fountains. Unit Cost: \$1,500 ea. Quantity: 2</p>	\$8,250
<b>TOTAL FOR DIGHTON MIDDLE SCHOOL:</b>		<b>\$27,700</b>

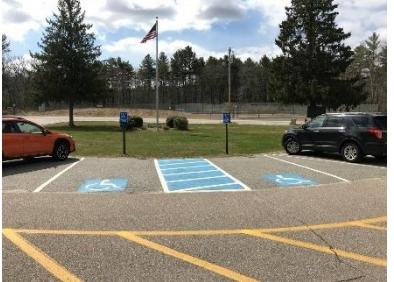
#	Barrier Statement	Photo	Proposed Mitigation	Cost
1.	<p><b>Accessible Parking – for Town Events</b></p> <p>The designated accessible parking spaces and their associated access aisle have slopes &gt;2%, @ up to 3%.</p> <p>The signs are mounted &lt;60" AFF, measured to the bottom of the sign, @ 55".</p> <p>The access aisle is &lt;96" wide, @ 76".</p> <p><i>KMA was informed on site that temporary parallel accessible parking spaces may be provided for Town events. KMA recommends reviewing the layouts, locations, and policies of these spaces.</i></p>

<p>Reinstall the signs at min. 60" AFF (including one van accessible sign), measured to the bottom of the sign.</p> <p>Unit Cost: \$100 per sign</p> <p>Quantity: 2</p> <p>Regrade and restripe the existing designated accessible parking spaces and their associated access aisle.</p> <p>Unit Cost: \$1,500 per space or aisle</p> <p>Est. Quantity: 3 (2 spaces + 1 aisle)</p>	\$4,700

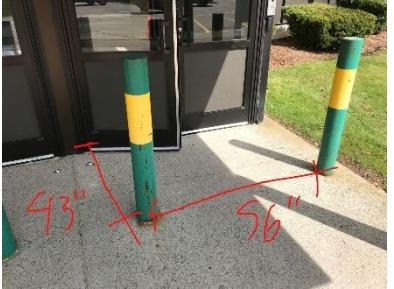
2.	<p><b>Accessible Route – Main Entry</b></p> <p>The pull-side door maneuvering clearance is &lt;60" perpendicular to the doorway, due to the location of the bollards.</p>

<p>Remove one of the bollards.</p> <p>Unit Cost: \$250</p> <p>Quantity: 1</p>	\$250

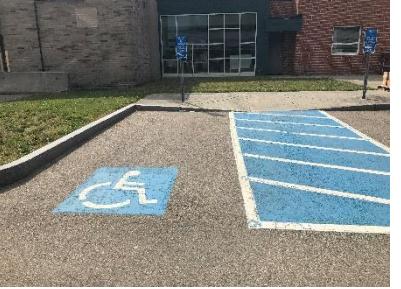
3.	<p><b>Accessible Parking – for School Committee</b></p> <p>The designated accessible parking spaces and their associated access aisle have slopes &gt;2%, @ up to 2.4%.</p> <p>The signs are mounted &lt;60" AFF, measured to the bottom of the sign, @ 53 1/2".</p> <p><i>KMA was informed on site that the School Committee uses these parking spaces and travel along the vehicular route to get into the building.</i></p>

<p>Regrade and restripe the existing designated accessible parking spaces and their associated access aisle.</p> <p>Unit Cost: \$1,500 per space or aisle</p> <p>Est. Quantity: 3 (2 spaces + 1 aisle)</p> <p>Reinstall the signs at min. 60" AFF (including one van accessible sign), measured to the bottom of the sign.</p> <p>Unit Cost: \$100 per sign</p> <p>Quantity: 2</p>	\$4,700

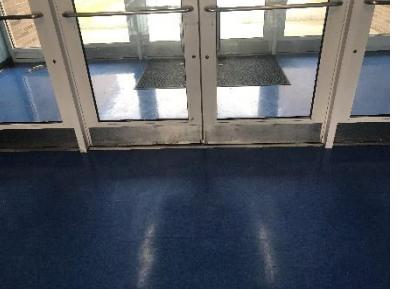
4.	<p><b>Accessible Route – School Committee Entry</b></p> <p>There is a change in level &gt; 0.25" at the entry door, @ 1".</p>

<p>Regrade the door landing.</p> <p>Unit Cost: \$1,000</p> <p>Quantity: 1</p>	\$1,000

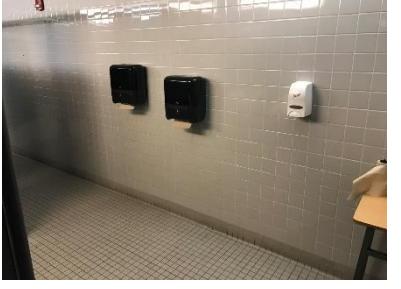
5.	<p><b>Toilet Room</b></p> <p>The dispensers protrude &gt;4" into the circulation space, @ 5-8".</p>

<p>Relocate the dispensers.</p> <p>Unit Cost: \$50 ea.</p> <p>Quantity: 3</p>	\$150

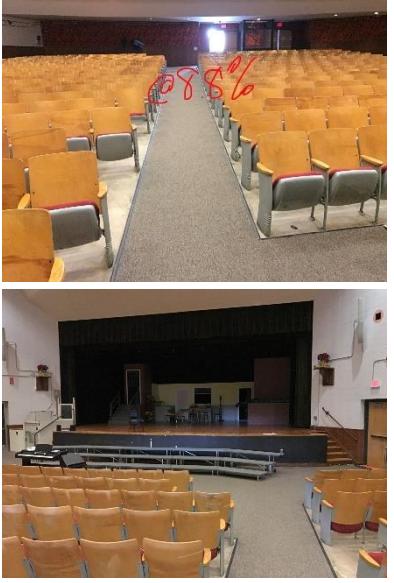
6.	<p><b>Auditorium</b></p> <p>The aisle has slope is &gt;8.3% at the top, @ 8.8%.</p> <p>The accessible route to the lift has running slopes &gt;5%, @ 7.7%.</p> <p>The stairs to the stage lacks handrails on both sides.</p> <p>The auditorium lacks the total number of required accessible seating spaces. For an assembly area with 840 total seats, nine accessible spaces need to be provided, and are required to be dispersed throughout.</p>

<p>Rebuild the aisle and route to the lift. Further design study required.</p> <p>Unit Cost: \$15,000</p> <p>Install handrails on both sides of the stairs.</p> <p>Unit Cost: \$50/LF</p> <p>Est. Quantity: 10 LF (5LF x 2)</p> <p>Provide the required number of accessible seats. Further design study required.</p> <p>Unit Cost: \$5,000</p>	\$20,500

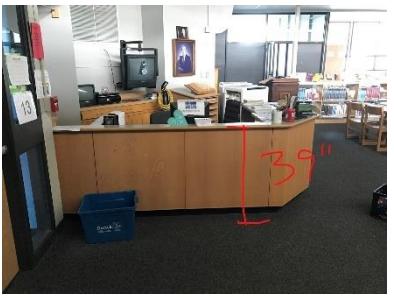
7.	<p><b>Media Center</b></p> <p>The service counter is &gt;36" AFF, @ 39".</p> <p><i>Note: It is unclear whether this space is used by the public.</i></p>

<p>Lower a 36" wide portion of the counter to max. 36" AFF.</p> <p>Unit Cost: \$750</p> <p>Quantity: 1</p>	\$750

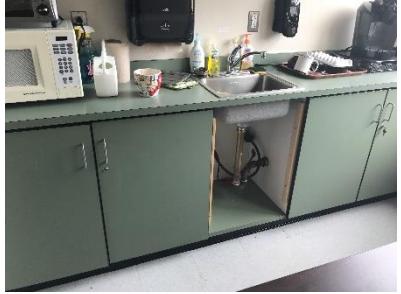
9.	<p><b>Breakroom</b></p> <p>The breakroom sink is mounted &gt;34" AFF, @ 36".</p> <p>The table lacks the required minimum 27" AFF knee space below, @ 26".</p>

<p>Lower the sink to max. 34" AFF. Unit Cost: \$3,000 ea. Quantity: 1</p> <p>Provide at least one table, and no less than 5% of the total number of tables, that provides compliant knee and toe clearance. Unit Cost: \$250 ea. Quantity: 1</p>	\$3,250
<b>TOTAL FOR DIGHTON-REHOBOTH HIGH SCHOOL:</b>				<b>\$36,300</b>

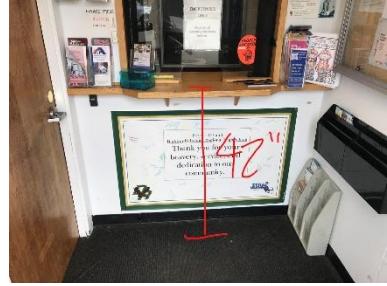
3.	<p><b>Service Counter</b></p> <p>The counter is &gt;36" AFF, @ 42".</p>

<p>Lower a 36" wide portion of the counter to max. 36" AFF.</p> <p>Unit Cost: \$750</p> <p>Quantity: 1</p>	\$750
<b>TOTAL FOR FIRE STATION 1:</b>				<b>\$4,100</b>

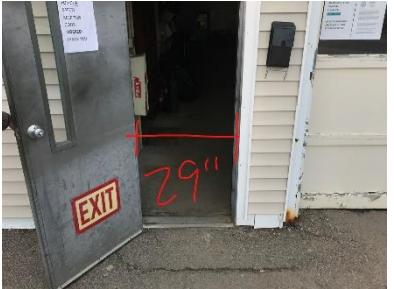
#	Barrier Statement	Photo	Proposed Mitigation	Cost
1.	<b>Accessible Employee Parking</b> Designated accessible parking is not provided.	No Photo	Stripe a portion of the parking lot to add a van accessible parking space, as well as its associated sign and access aisle. Unit Cost: \$300 per space or aisle Est. Quantity: 2 (1 space + 1 aisle)	\$600
2.	<b>Main Entrance</b> The door provides <32" clear width, @ 29".

Enlarge the door opening and install a new door. Unit Cost: \$5,000 ea. Quantity: 1	\$5,000
3.	<b>Door to Employee Toilet Room</b> The door provides <32" clear width. The door has a vertical change in level >0.25" AFF, due to the step.

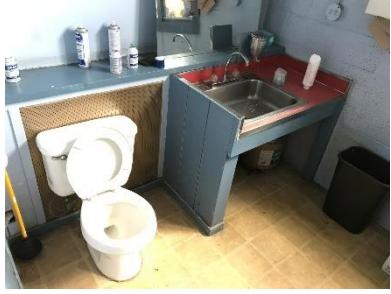
4.	<b>Employee Toilet Room</b> The bathroom lacks the required footprint and accessible elements for an accessible toilet room.

Further design study required. Unit Cost: \$5,000 ea. Quantity: 1	\$5,000
<b>TOTAL FOR HIGHWAY DEPARTMENT GARAGE:</b>				<b>\$20,600</b>

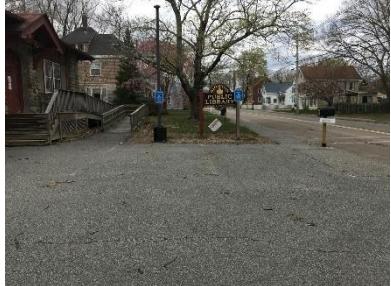
#	Barrier Statement	Photo	Proposed Mitigation	Cost
1.	<p><b>Accessible Parking</b></p> <p>The designated accessible parking spaces lack an associated access aisle.</p> <p>The designated accessible parking spaces have slopes &gt;2%, @ up to 3.6%.</p>

<p>Regrade and restripe the designated accessible parking spaces and their associated access aisle.</p> <p>Unit Cost: \$1,500 per space or aisle</p> <p>Est. Quantity: 3 (2 spaces + 1 aisle)</p>	\$4,500

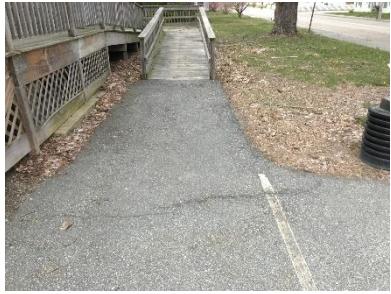
2.	<p><b>Accessible Route</b></p> <p>The route from the parking to the ramp has cross slopes &gt;2%, @ 3.1%.</p> <p>The ramp handrails do not have a circular profile and lack the required extensions.</p> <p>The ramp has running slopes &gt;8.3%, @ 10.9% along the lower leg, and 8.6% along the upper leg.</p>

<p>Regrade the walkway.</p> <p>Unit Cost: \$25/SF</p> <p>Est. Quantity: 10 SF</p> <p>Rebuild the ramp.</p> <p>Unit Cost: \$15,000 ea.</p> <p>Quantity: 1</p>	\$15,250

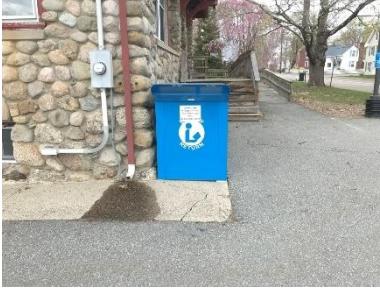
3.	<p><b>Book Return Box</b>            The book return slot is &gt;48" AFF, @ 49.5".</p>

Modify the drop-off box so the control is max. 48" AFF. Unit Cost: \$500 Quantity: 1	\$500
4.	<p><b>Seating &amp; Computer Station</b>            The knee clearance at the reading table is &lt;27" AFF, @ 24".            The knee clearance at the computer station is &lt;27", @ 24".</p>

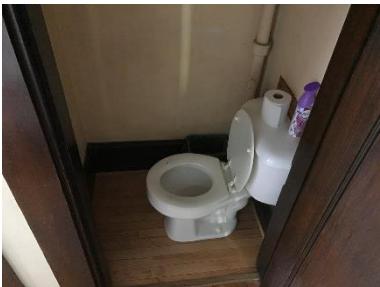
Provide at least one table, and no less than 5% of the total number of tables, that provides compliant knee and toe clearance. Unit Cost: \$250 ea. Quantity: 2	\$500
5.	<p><b>Toilet Room</b>            The bathroom lacks the required footprint and accessible elements for an accessible toilet room.</p>

Further design study required. Unit Cost: \$5,000 ea. Quantity: 1	\$5,000

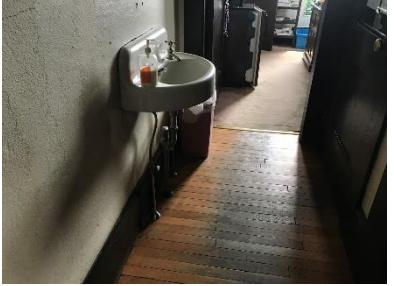
6.	<p><b>Sink in Hallway</b></p> <p>The knee clearance at the sink is &lt;27" AFF, @ 25".</p> <p>The sink protrudes &gt;4" into the circulation.</p>

<p>See mitigation above. Unit Cost: \$0 Quantity: -</p>	\$0
7.	<p><b>Lower Level</b></p> <p>An accessible route is not provided to the lower level due to the stairs.</p> <p><i>KMA understands the Children's Room is located on the lower level of the building.</i></p>	No Image	<p>Add an elevator. Further design study required. Unit Cost: \$50,000 ea. Quantity: 1</p>	\$50,000
<b>TOTAL FOR LIBRARY:</b>		<b>\$75,750</b>

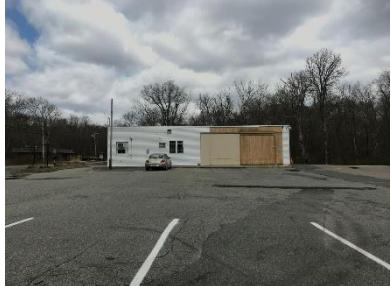
#	<i>Barrier Statement</i>	<i>Photo</i>	<i>Proposed Mitigation</i>	<i>Cost</i>
1.	<b>Accessible Parking</b> Designated accessible parking is not provided.

Restripe the existing parking spaces to add a van accessible parking space as well as its associated sign and access aisle. Unit Cost: \$300 per space or aisle Est. Quantity: 2 (1 space + 1 aisle)	\$600
2.	<b>Accessible Route</b> The entrance lacks an accessible route due to the 6" step.

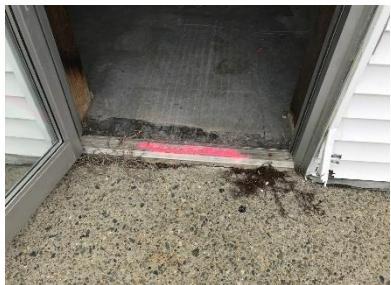
Install a curb ramp. Unit Cost: \$1,250 Quantity: 1	\$1,250
3.	<b>Entry Door</b> The threshold is > 0.5" AFF, @ 1.375".

Replace the threshold. Unit Cost: \$250 ea. Quantity: 1	\$250
<b>TOTAL FOR OLD POLICE STATION:</b>				<b>\$2,100</b>

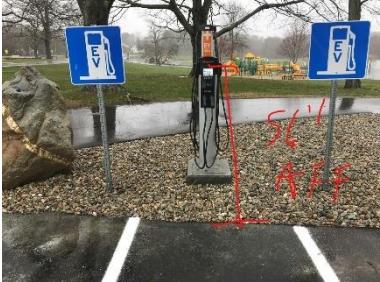
#	Barrier Statement	Photo	Proposed Mitigation	Cost
1.	<p><b>EV Charging Stations</b></p> <p>The controls are &gt;48" AFF, @ 56" measured to the top of the touch screen.</p> <p>The charger is not located on a 36" wide accessible route, due to the change in surface material.</p>

<p>Replace and relocate the station so it is located on an accessible route and provides controls @ max. 48" AFF.</p> <p>Unit Cost: \$1,000 ea.</p> <p>Quantity: 1</p>	\$1,000

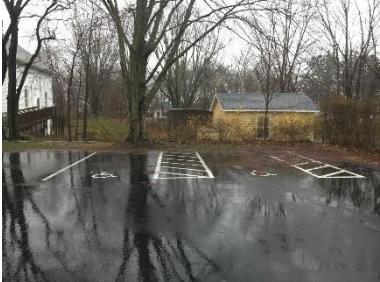
2.	<p><b>Accessible Parking - Front Lot</b></p> <p>The accessible parking spaces lack the required signage at the head of the space.</p> <p>The access aisle is &lt;96" wide.</p>

<p>Add signs to the heads of the spaces (including a van accessible sign), @ min. 60" AFF measured to the bottom of the sign.</p> <p>Unit Cost: \$100</p> <p>Quantity: 2</p> <p>Restripe the designated accessible spaces and their associated access aisle.</p> <p>Unit Cost: \$300 per space or aisle</p> <p>Quantity: 1 (0 spaces + 1 aisle)</p>	\$500

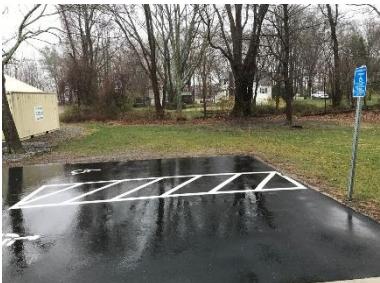
3.	<p><b>Accessible Parking - Back Lot</b></p> <p>One of the accessible parking spaces lacks the required signage at the head of the space.</p> <p>The designated accessible parking space lacks a van accessible sign.</p> <p>The access aisle is &lt;96" wide, @ 60".</p> <p>The designated accessible parking space and its associated access aisle have slopes &gt; 2%, @ 4.1%.</p>

<p>Install signs at the head of the spaces (including a van accessible sign), at min. 60" AFF measured to the bottom of the sign.</p> <p>Unit Cost: \$100</p> <p>Quantity: 2</p> <p>Regrade and restripe the existing designated accessible parking space and its associated access aisle.</p> <p>Unit Cost: \$1,500 per space or aisle</p> <p>Quantity: 3 (2 spaces + 1 aisle)</p>	\$4,700

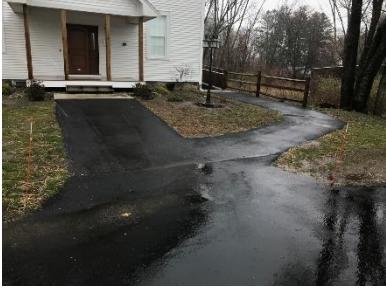
4.	<b>Accessible Route</b> The main entrance lacks directional signage to the accessible entrance.

Provide directional signage to the accessible entry. Unit Cost: \$100 ea. Est. Quantity: 1	\$100
5.	<b>Ramp</b> The ramp lacks the required handrail extensions at the bottom.

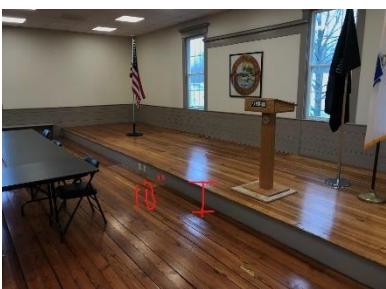
Install an automatic door opener. Unit Cost: \$2,500 ea. Quantity: 1	\$2,500
7.	<b>Stage</b> An accessible route is not provided to the stage due to the 10" step.

Provide an accessible route to the stage. Additional study required. Unit Cost: \$1,000 Quantity: 1	\$1,000

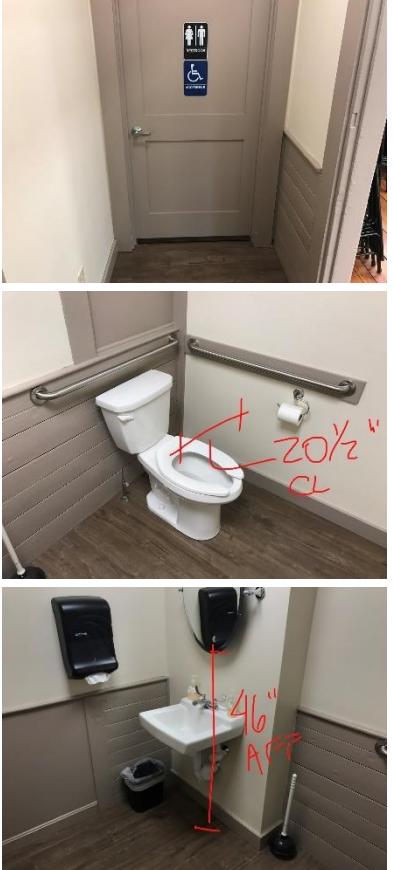
8.	<p><b>Accessible Single-User Toilet Room</b></p> <p>The sign is not located on the latch side of the door.</p> <p>The door maneuvering clearance is &lt;12" on the latch push-side for a forward approach, @ 6.25".</p> <p>The toilet centerline is &gt;18" from the side wall, @ 18.25".</p> <p>The side wall grab bar extends &lt;54" from the rear wall, @ 40.75".</p> <p>The mirror is &gt;40" AFF, @ 46" measured to the bottom of the reflective surface.</p> <p>The paper towel dispenser protrudes &gt;4" into the circulation space, @ 6".</p> <p>The coat hook is mounted &gt;48" AFF, @ 60".</p>

<p>Install tactile/ Braille signage on the latch side of the door. Coordinate with location and height requirements.</p> <p>Unit Cost: \$100 per sign</p> <p>Quantity: 1</p> <p>Install an automatic door opener.</p> <p>Unit Cost: \$2,500 ea.</p> <p>Quantity: 1</p> <p>Reposition the toilet.</p> <p>Unit Cost: \$1,500 ea.</p> <p>Quantity: 1</p> <p>Install a min. 42" side grab bar, located 12" from the interior corner of the wall.</p> <p>Unit Cost: \$50 ea.</p> <p>Quantity: 1</p> <p>Lower the mirror.</p> <p>Unit Cost: \$50 ea.</p> <p>Quantity: 1</p> <p>Relocate the dispenser.</p> <p>Unit Cost: \$50 ea.</p> <p>Quantity: 1</p> <p>Install a coat hook no higher than 48" AFF.</p> <p>Unit Cost: \$50 ea.</p> <p>Quantity: 1</p>	\$4,300

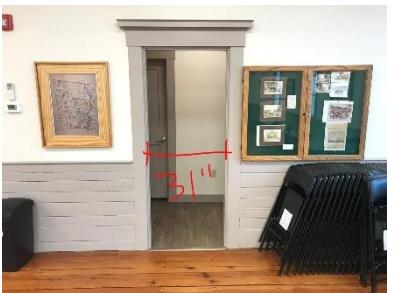
9.	<p><b>Interior Route to Toilet Rooms</b></p> <p>The accessible route to the toilet rooms is &lt;32" wide, @ 31" at the cased opening.</p>

<p>Enlarge the opening. Additional study required.</p> <p>Unit Cost: \$1,000 ea.</p> <p>Quantity: 1</p>	\$5,000

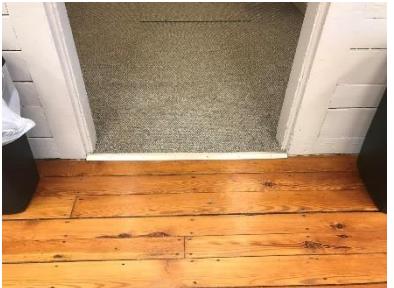
11.	<b>Interior Route to Main Entry Foyer</b> The opening threshold is >0.5" AFF, @ 0.75" and the bevel is not 1:2.

Replace the threshold. Unit Cost: \$250 ea. Quantity: 1	\$250

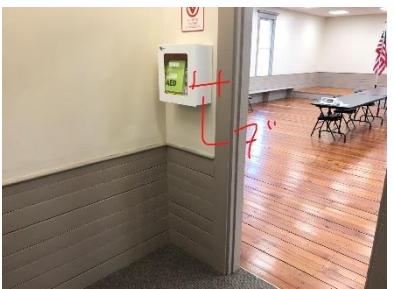
12.	<b>Main Entry Foyer</b> The defibrillator controls are mounted >48" AFF.

Lower the defibrillator controls to max. 48" AFF. Unit Cost: \$100 Quantity: 1	\$100

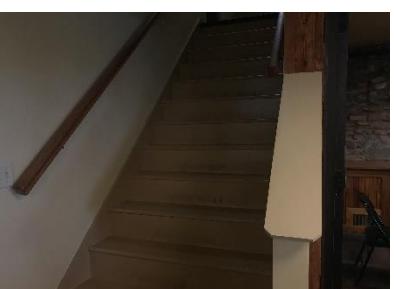
13.	<b>Stairs</b> The stairs lack the required handrails and handrail extensions on both sides.  <i>Note: there is no interior accessible route between the levels of this building. Since the building is less than three stories it meets the exception of ADA-206.2.3</i>

Install compliant handrails on both sides. Unit Cost: \$50/LF Est. Quantity: 60 LF	\$3,000

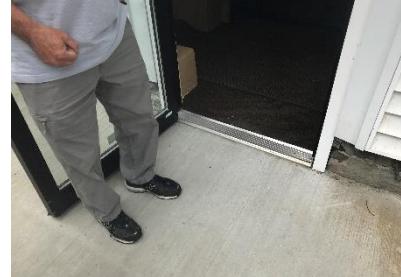
14.	<p><b>Entry – Lower Level</b></p> <p>The exterior threshold is &gt;0.5" AFF, @ 0.625".</p> <p>Two of the doors lack the required minimum 10" AFF of smooth surface along the bottom of the push side.</p> <p>The curb obstructs the required minimum 12" of maneuvering clearance on the latch push side of the entry door within 8" of the face of the door.</p>

<p>Replace the threshold. Unit Cost: \$250 ea. Quantity: 1</p> <p>Install a kick plate that is minimum 10" tall on the bottom of the push side of the door. Unit Cost: \$250 ea. Quantity: 2</p> <p>Install an automatic door opener. Unit Cost: \$2,500 Quantity: 1</p>	\$3,250

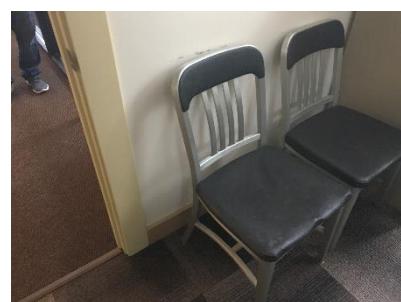
15.	<p><b>Veteran's Office – Lower Level</b></p> <p>The entry door to the Veteran's Office lacks the required minimum 18" of maneuvering clearance on the latch pull side for a forward approach, due to the location of furniture.</p>

<p>Remove the chairs. Unit Cost: \$50 Quantity: 1</p>	\$50

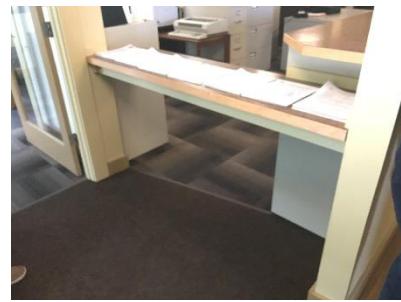
16.	<p><b>Offices – Lower Level</b></p> <p>The office counters are &gt;36" AFF, however there is a lower counter near the entry door. KMA was informed on site that the lower counter is available for use by all departments on the lower level.</p>

<p>Ensure the policy is clear to all staff using the offices in the lower level.</p>	N/A

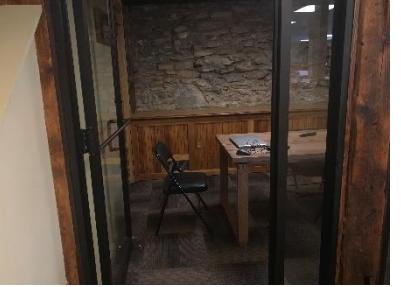
17.	<p><b>Conference Room – Lower Level</b></p> <p>The entry door lacks the required minimum 10" AFF of smooth surface along the bottom of the push side.</p> <p>The table lacks the required minimum 27" AFF of knee clearance below, @ 26".</p> <p>Furniture obstructs the required door maneuvering clearance and turning space within the room.</p> <p>The coat hooks are mounted &gt;48" AFF, @ 66".</p>

<p>Install a kick plate that is minimum 10" tall on the bottom of the push side of the door.</p> <p>Unit Cost: \$250 ea.</p> <p>Quantity: 1</p> <p>Provide at least one table, and no less than 5% of the total number of tables, that provides compliant knee and toe clearance. Ensure the table does not obstruct the required door maneuvering clearance or turning space.</p> <p>Unit Cost: \$250 ea.</p> <p>Quantity: 1</p> <p>Install a coat hook mounted no higher than 48" AFF.</p> <p>Unit Cost: \$50 ea.</p> <p>Quantity: 1</p>	\$550

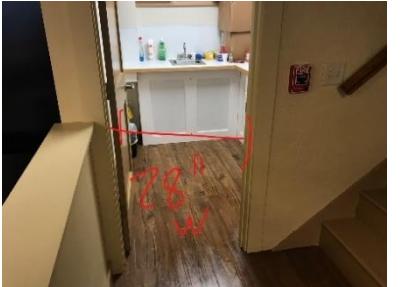
18.	<p><b>Employee Break Room - Lower Level</b></p> <p>The employee break room is not on an accessible route, due to the step.</p> <p>The entrance door provides &lt;32" clear width, @ 28".</p> <p>The sink is mounted &gt;34" AFF and lacks the required knee/ toe clearance for a forward approach.</p>

<p>Provide an accessible route to the break room. Further design study required.</p> <p>Unit Cost: \$1,000</p> <p>Enlarge door opening and install a new door.</p> <p>Unit Cost: \$5,000 ea.</p> <p>Quantity: 1</p> <p>Lower the sink to max. 34" AFF.</p> <p>Unit Cost: \$3,000 ea.</p> <p>Quantity: 1</p>	\$9,000

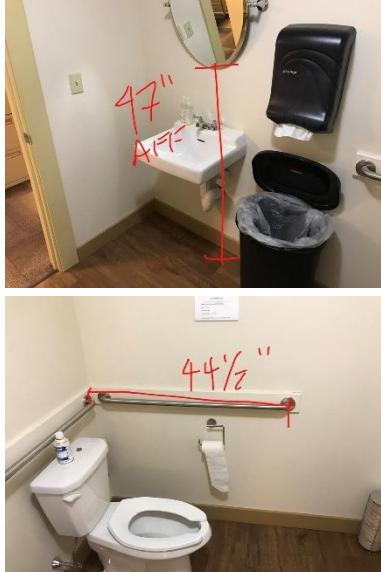
19.	<p><b>Single-User Toilet Room – Lower Level</b></p> <p>The mirror is &gt;40" AFF, @ 47" measured to the bottom of the reflective surface.</p> <p>The toilet centerline is &gt;16-18" from the side wall, @ 21.25".</p> <p>The side grab bar extends &lt;54" from the rear wall, @ 44.5".</p> <p>The toilet paper dispenser is not located 7-9" from the front edge of the toilet.</p> <p>The entry door lacks the required minimum 18" of maneuvering clearance on the latch pull side for a forward approach, due to the location of the lavatory.</p> <p>The tactile/braille signage is not mounted on the latch side of the door.</p>

<p>Lower the mirror. Unit Cost: \$50 ea. Quantity: 1</p> <p>Reposition the toilet. Unit Cost: \$1,500 ea. Quantity: 1</p> <p>Install a min. 42" side grab bar, located 12" from the interior corner of the wall. Unit Cost: \$50 ea. Quantity: 1</p> <p>Relocate the toilet paper dispensers. Unit Cost: \$50 ea. Quantity: 1</p> <p>Install an automatic door opener. Unit Cost: \$2,500 Quantity: 1</p> <p>Install tactile/ Braille signage on the latch side of the door. Coordinate with location and height requirements. Unit Cost: \$100 per sign Quantity: 1</p>	\$4,250

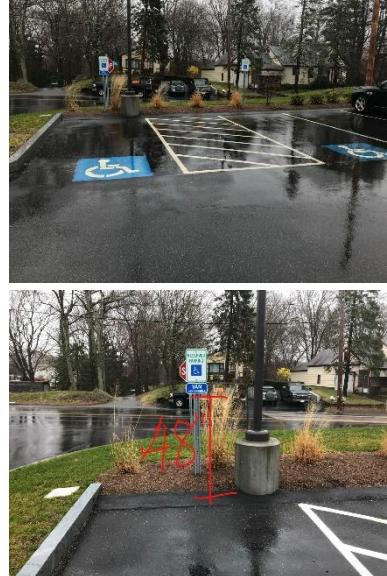
#	Barrier Statement	Photo	Proposed Mitigation	Cost
1.	<b>Accessible Parking</b> One of the designated accessible parking spaces and its associated access aisle have slope >2%, @ 2.2%. One sign is mounted <60" AFF, @ 48" measured to the bottom of the sign.

Regrade and restripe the existing designated accessible parking space and its associated access aisle. Unit Cost: \$1,500 per space or aisle Quantity: 2 (1 space + 1 aisle)  Install new signs at min. 60" AFF (including a van accessible sign), measured to the bottom of the sign. Unit Cost: \$100 ea. Quantity: 1	\$3,100
2.	<b>Toilet Room</b> The mirror is >40" AFF, @ 41" measured to the bottom of the reflective surface.

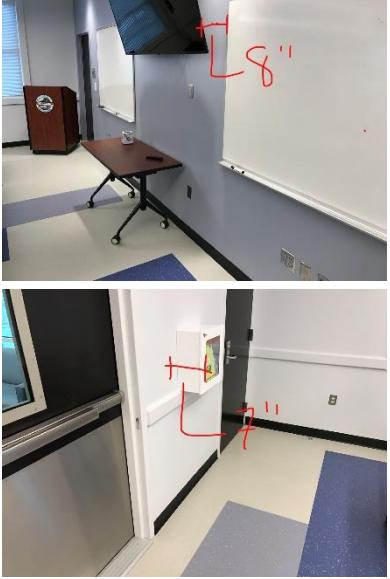
3.	<p><b>Common-Use Meeting Room</b></p> <p>The phone protrudes &gt;4" into the circulation space, @ 5".</p> <p>The TV protrudes &gt;4" into the circulation space, @ 8".</p> <p>The AED box protrudes &gt;4" into the circulation space, @ 7".</p>

<p>Relocate the objects. Unit Cost: \$100 ea. Quantity: 3</p>	\$300
4.	<p><b>Jail Cell</b></p> <p>The toilet CL is &gt;18" from the sidewall, @ 20.5".</p> <p>The flush controls are not mounted on the wide side of the toilet.</p>

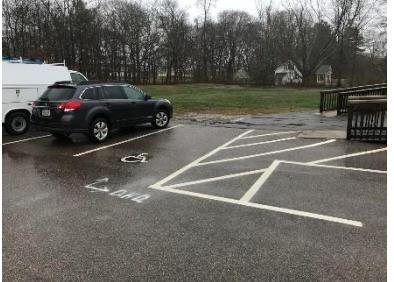
#	Barrier Statement	Photo	Proposed Mitigation	Cost
1.	<b>Accessible Parking</b> The accessible parking space lacks the required signage at the head of the space. The access aisle has cross slope >2%, @ up to 5.5%. The access aisle is <96" wide.

Install new signs at min. 60" AFF (including a van accessible sign), measured to the bottom of the sign. Unit Cost: \$100 ea. Quantity: 1  Regrade and restripe the existing designated accessible parking space and its associated access aisle. Unit Cost: \$1,500 per space or aisle Quantity: 2 (1 space + 1 aisle)	\$3,100

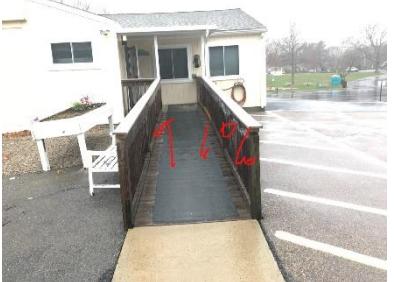
2.	<b>Accessible Route</b> The slope of the ramp is >8.3%, @ up to 9.6%. The ramp handrails lack a circular profile and the required extensions.

Rebuild the ramp. Unit Cost: \$15,000 ea. Quantity: 1	\$15,000

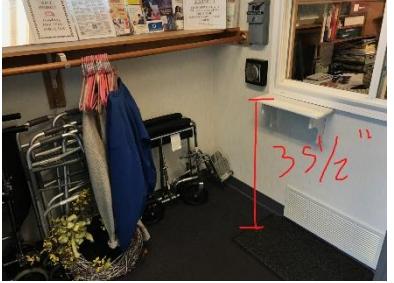
3.	<b>Service Counter</b> The counter is <36" wide.

Install a 36" wide portion of the counter to 36" max. AFF. Unit Cost: \$750 Quantity: 1	\$750

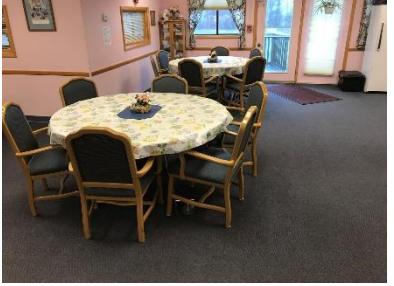
4.	<p><b>Seating</b> The tables lack the required knee/ toe clearances.</p>

<p>Provide at least one table, and no less than 5% of the total number of tables, that provides compliant knee/ toe clearances. Unit Cost: \$250 ea. Est. Quantity: 1</p>	\$250
5.	<p><b>Interior Route</b> The emergency box protrudes &gt;4" into the circulation space, @ 5.25".</p>

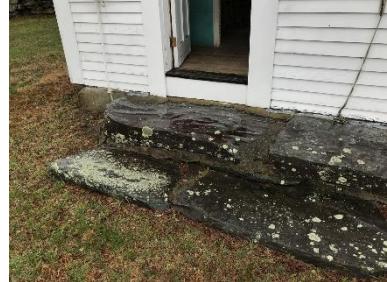
#	<i>Barrier Statement</i>	<i>Photo</i>	<i>Proposed Mitigation</i>	<i>Cost</i>
1.	<b>Accessible Route</b> An accessible route is not provided to the entry door due to the steps.

Provide an accessible route to the door. Additional study required. Unit Cost: \$1,000 Quantity: 1	\$1,000
<b>TOTAL FOR SEGREGANSETT SCHOOL:</b>				<b>\$1,000</b>

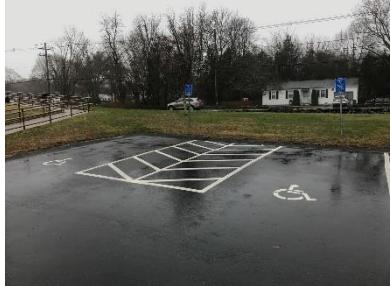
#	Barrier Statement	Photo	Proposed Mitigation	Cost
1.	<p><b>Accessible Parking - Main Level</b></p> <p>The designated accessible parking spaces have slopes &gt;2%, @ up to 3.6%.</p> <p>The signs are mounted &lt;60" AFF, @ 55.5" measured to the bottom of the sign.</p>

<p>Regrade and restripe the existing designated accessible parking space and its associated access aisle.</p> <p>Unit Cost: \$1,500 per space or aisle</p> <p>Quantity: 3 (2 spaces + 1 aisle)</p> <p>Install new signs (including a van accessible sign), at min. 60" AFF measured to the bottom of the sign.</p> <p>Unit Cost: \$100 ea.</p> <p>Quantity: 2</p>	\$4,700

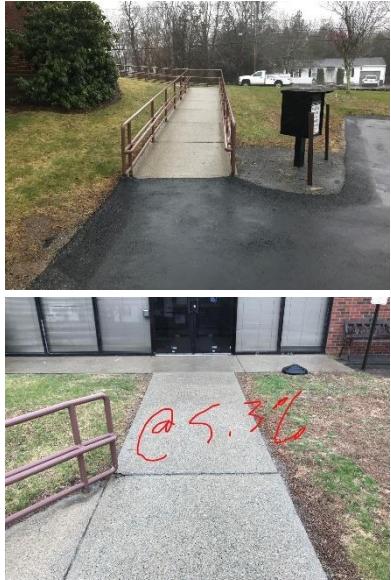
2.	<p><b>Accessible Route to Main Level</b></p> <p>The ramp has running slopes &gt;8.3%, @ up to 9.9%.</p> <p>The route from the accessible parking to the ramp has running slopes &gt;5% but is not treated as a ramp, @ 5.3%.</p>

<p>Rebuild the ramp.</p> <p>Unit Cost: \$15,000 ea.</p> <p>Quantity: 1</p> <p>Regrade the walkway.</p> <p>Unit Cost: \$25/SF</p> <p>Est. Quantity: 100 SF</p>	\$17,500

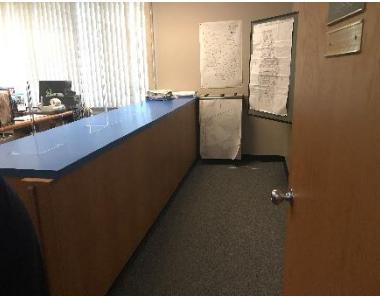
5.	<p><b>Door Hardware – Typical</b></p> <p>The door hardware requires tight grasping, pinching, or twisting of the wrist to operate.</p> <p><i>This condition was observed at the Treasurer's Office, the Assessor's Office, the Accountant's Office, and at the storage.</i></p>

<p>Replace the door hardware with lever type.</p> <p>Unit Cost: \$300 ea. Est. Quantity: 8</p>	\$2,400

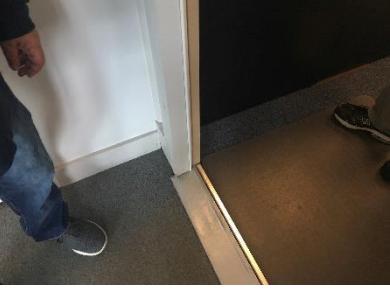
6.	<p><b>Thresholds – Typical</b></p> <p>The thresholds are not beveled at maximum 1:2, there are two vertical rises.</p> <p><i>This condition was observed at the Sewer/Planning and ZBA Offices.</i></p>

<p>Replace the threshold.</p> <p>Unit Cost: \$250 ea.</p> <p>Quantity: 2</p>	\$500

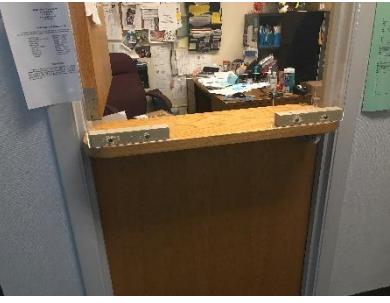
7.	<p><b>Counters – Typical</b></p> <p>The service counters are &gt;36" AFF, @ 42".</p> <p>Some of the service counters obstruct the required minimum 36" wide accessible route into the offices.</p> <p><i>This condition was observed at the Selectman's Office, the Town Administration Office, and the Clerk's Office.</i></p>

<p>Lower and/or relocate a 36" wide portion of the counter to 36" max. AFF.</p> <p>Unit Cost: \$750</p> <p>Est. Quantity: 3</p>	\$2,250

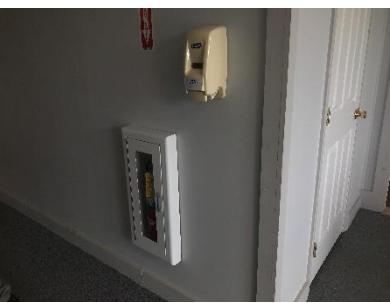
8.	<p><b>Hand Sanitizer Dispensers – Typical</b></p> <p>The hand sanitizer dispensers protrude &gt;4" into the circulation space.</p>

<p>Install a cane detectable object below the dispensers.</p> <p>Unit Cost: \$250 ea.</p> <p>Est. Quantity: 5</p>	\$1,250

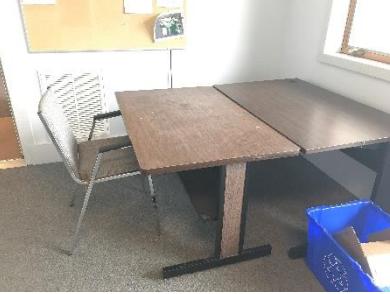
9.	<p><b>ZBA Office - Lower Level</b></p> <p>The entry door lacks the required minimum 18" of maneuvering clearance on the latch pull side for a forward approach, @ 8" to the desk.</p> <p>The desks outside of the ZBA Office lack the required minimum 27" AFF of knee clearance below for a forward approach.</p>

<p>Relocate the desk. Unit Cost: \$50 Quantity: 1</p> <p>Provide at least one table, and no less than 5% of the total number of tables, that provides compliant knee and toe clearance. Unit Cost: \$250 ea. Est. Quantity: 1</p>	\$300
10.	<p><b>Selectman's Meeting Room - Main Level</b></p> <p>The door maneuvering clearance is &lt;18" on the latch pull-side for forward approach, @ 12.5".</p>

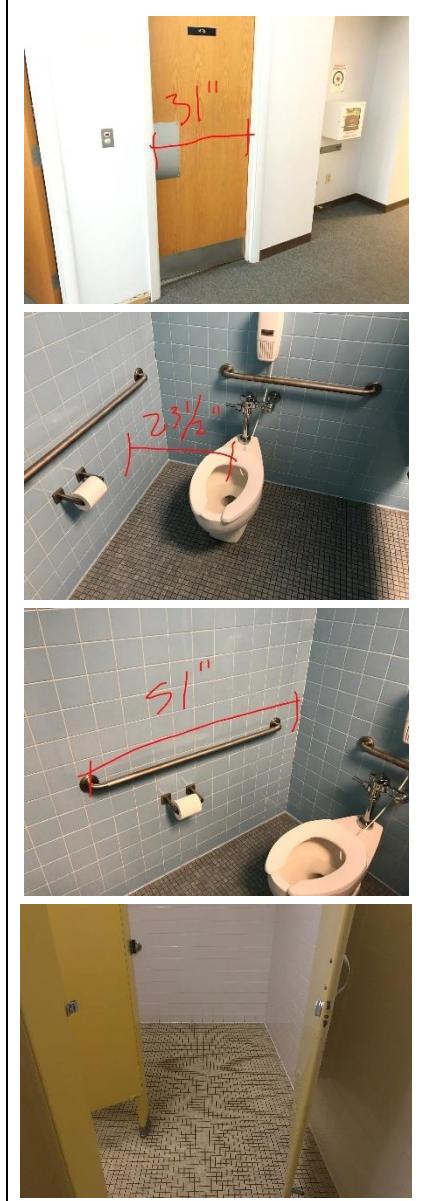
11.	<p><b>Multi-User Toilet Rooms (2) - Main Level</b></p> <p>The entrance door provides &lt;32" clear width, @ 31".</p> <p>The toilet centerlines are &gt;18" from the side wall, @ 23"-23.5".</p> <p>In the men's room, the flush valve is not located on the open side of the toilet.</p> <p>The rear grab bar starts &gt;12" from the side wall, @ 17.5".</p> <p>The side grab bars extend &lt;54" from the rear wall, @ 51".</p> <p>The coat hooks are mounted &gt;48" AFF, @ 69".</p> <p>The paper towel controls are mounted &gt;48" AFF.</p> <p>The accessible stall door in the women's room lacks the required minimum 18" of maneuvering clearance on the latch pull side for a forward approach.</p> <p>The entry door to the women's room lacks the required minimum 18" of maneuvering clearance on the latch pull side for a forward approach, @ 12 1/2".</p>

<p>Enlarge the door opening and install a new door. Unit Cost: \$5,000 ea. Quantity: 2</p> <p>Reposition the toilet. Unit Cost: \$1,500 ea. Quantity: 2</p> <p>Reposition the flush valve or install an automatic flush control. Unit Cost: \$1,000 ea. Quantity: 1</p> <p>Install a min. 42" side grab bar, located 12" from the interior corner of the wall. Unit Cost: \$50 ea. Quantity: 2</p> <p>Install a min. 36" rear grab bar, located 6" from the interior corner of the wall. Unit Cost: \$50 ea. Quantity: 2</p> <p>Install a coat hook no higher than 48" AFF. Unit Cost: \$50 ea. Quantity: 2</p> <p>Relocate the dispensers. Unit Cost: \$50 ea. Quantity: 2</p> <p>Install an automatic door opener. Unit Cost: \$2,500 Quantity: 2</p>	\$19,400

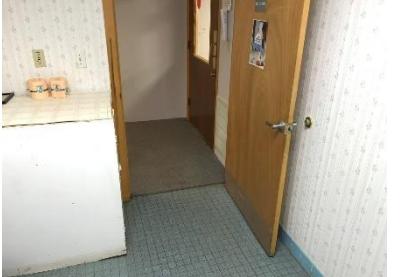
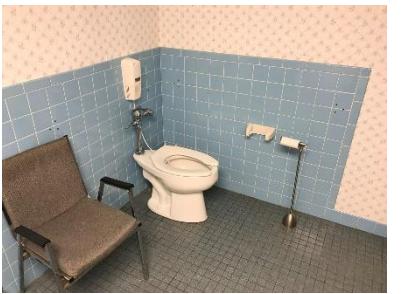
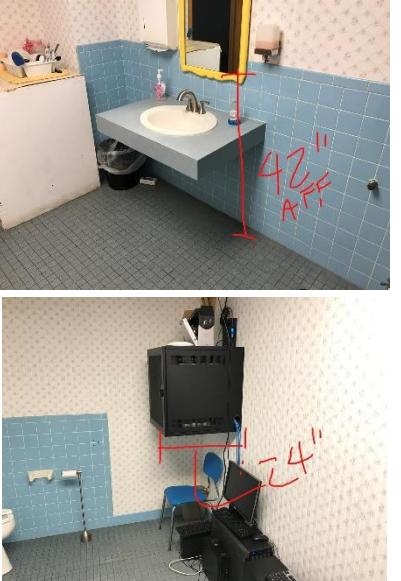
14.	<p><b>Single-User Toilet Rooms - Lower Level (2)</b></p> <p>The door maneuvering clearance at the Men's Room is &lt;18" on the latch pull-side for a forward approach, @ 3.5".</p> <p>The maneuvering clearance at the door to the Women's Room is &lt;18" on the latch pull-side for a forward approach, @ 10.5".</p> <p>In one of the toilet rooms, the mirror is &gt;40" AFF, @ 42" measured to the bottom of the reflective surface.</p> <p>The utilities box protrudes &gt;4" into the circulation, @ 24" and &gt;27" AFF.</p> <p>In one of the toilet rooms, the toilet lacks the required grab bars.</p>

<p>Install an automatic door opener. Unit Cost: \$2,500 ea. Quantity: 2</p> <p>Lower the mirror. Unit Cost: \$50 ea. Quantity: 1</p> <p>Install a cane detectable object below the utilities box. Unit Cost: \$250 ea. Quantity: 1</p> <p>Install a min. 36" rear grab bar, located 6" from the interior corner of the wall. Unit Cost: \$50 ea. Quantity: 1</p> <p>Install a min. 42" side grab bar, located 12" from the interior corner of the wall. Unit Cost: \$50 ea. Quantity: 1</p>	\$5,400

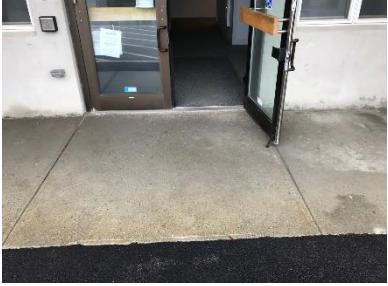
15.	<b>Building Entrance - Lower Level</b>  The door lacks a level landing, @ 3.5%.  The threshold is >0.5" AFF, @ 0.75" with no bevel.

Regrade the door landing. Unit Cost: \$1,000 Quantity: 1  Replace the threshold. Unit Cost: \$250 ea. Quantity: 1	\$1,250
16.	<b>Drinking Fountain - Lower Level</b>  The knee clearance at the drinking fountain is <27" AFF, @ 26.5".  The lower floor lacks a 'hi' drinking fountain.

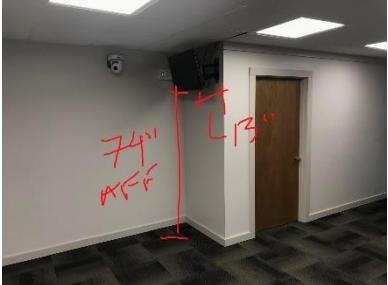
Relocate the drinking fountain so it provides the required knee clearance. Unit Cost: \$1,500 ea. Quantity: 1  Provide a 'hi' drinking fountain per ADA-602. Unit Cost: \$1,000 ea. Quantity: 1	\$2,500
17.	<b>Conference Room - Lower Level</b>  The TV protrudes >4" into the circulation space, @ 13".

Relocate the TV. Unit Cost: \$250 ea. Quantity: 1	\$250
<b>TOTAL FOR TOWN HALL:</b>				<b>\$115,650</b>
<b>TOTAL FOR DIGTON BUILDINGS:</b>				<b>\$388,400</b>
